FI Missouri Remediation Trust

Re: Administrative Settlement and Order on Consent for Treatability Study ("TS"), Docket No. CERCLA -07-2016-0004 (the "Settlement")
FI Missouri Remediation Trust Property, Joplin, Missouri

Photographic Documentation

RE: Construction Summary Report
Lateral Drain System
Former Farmland Industries Site
Joplin, Missouri

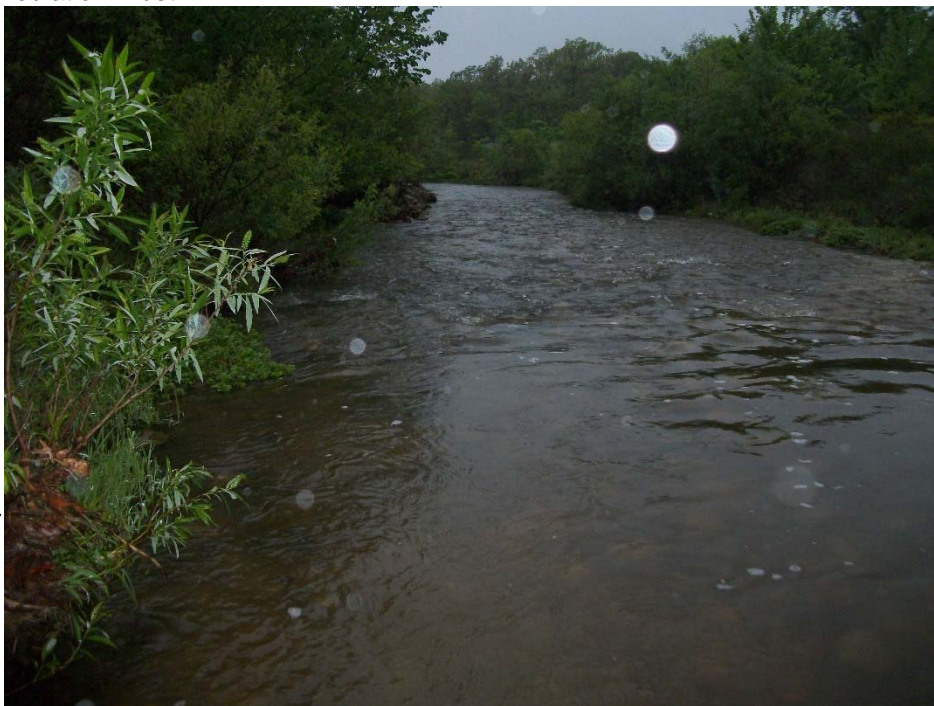
Description: Photo 33
Short Creek – High Water

Preclearing conditions are documented in Photographs 13 and 14. High flow conditions following the creek clearing are documented in Photograph 33.

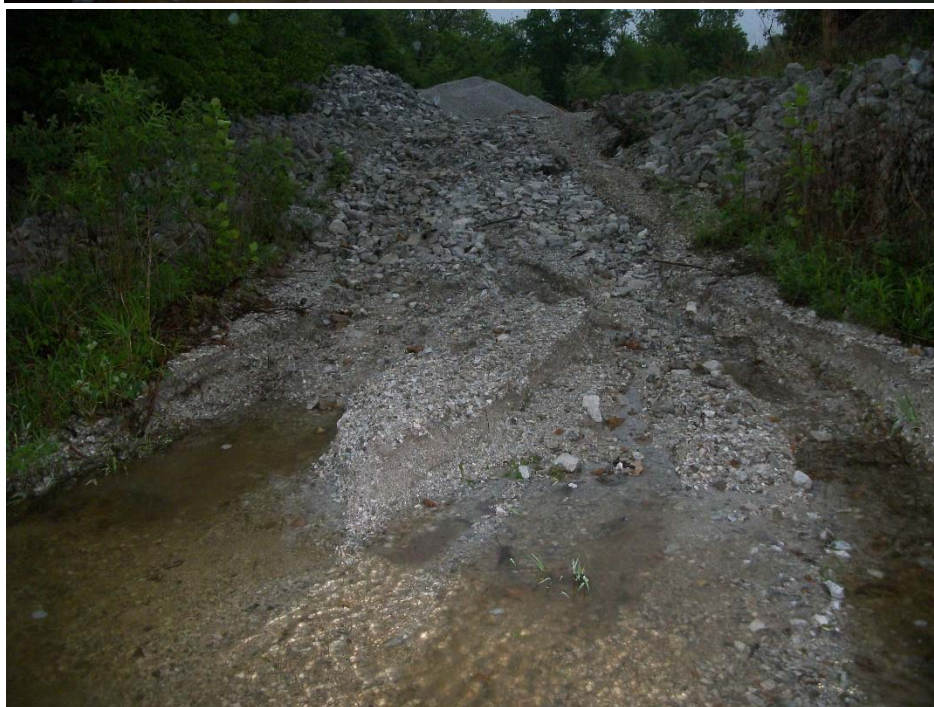
Description: Photo 34
Short Creek Crossing –
Damaged

On April 26, 2017, repairs were made to the south ramp of the Short Creek crossing. Runoff from recent rains eroded the ramp resulting in deep gullies and loss of gravel, Photograph 34. The ramp was graded and 1-inch gravel was placed on the ramp to provide a uniform surface and grade, Photograph 35. A gentle mound of gravel approximately 6 inches high was constructed at the top of the ramp oriented normal to the road to divert surface water flow around the ramp, Photograph 36.

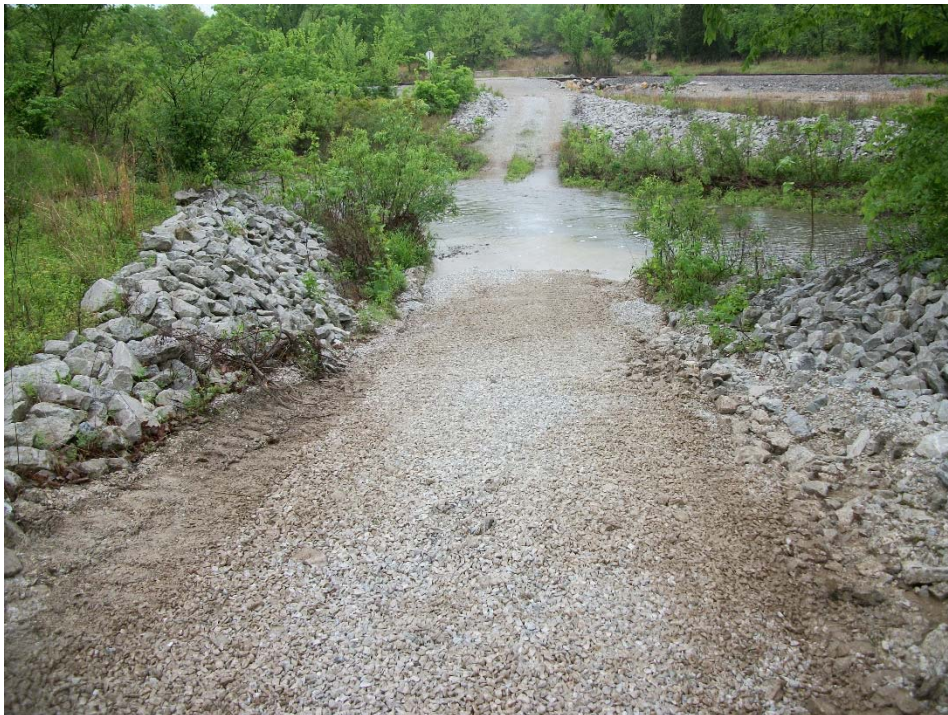
Description: Photo 35
Short Creek Crossing -
Repaired

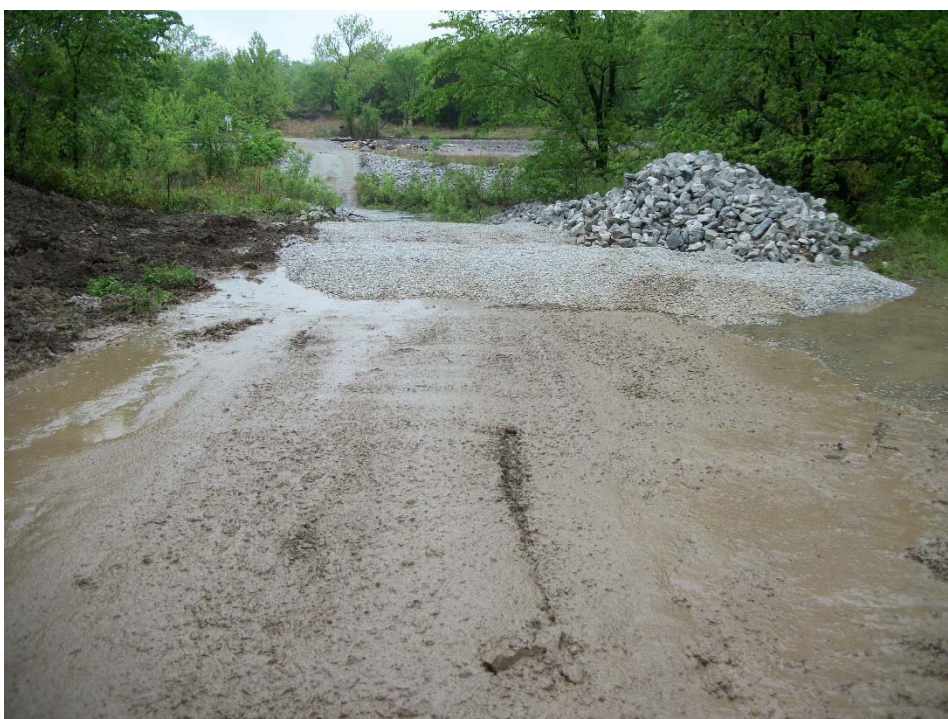
Description: Photo 36
Short Creek Crossing -
Top Berm
